Asbestos Survey for Demolition
Residence at 4402 South Bell Avenue, Kerman
HMS, Inc. Project No. F12273

LIMITED
LEAD BASED PAINT SURVEY
By XRF

RESIDENCE AT
4402 SOUTH BELL AVENUE
FRESNO, CA

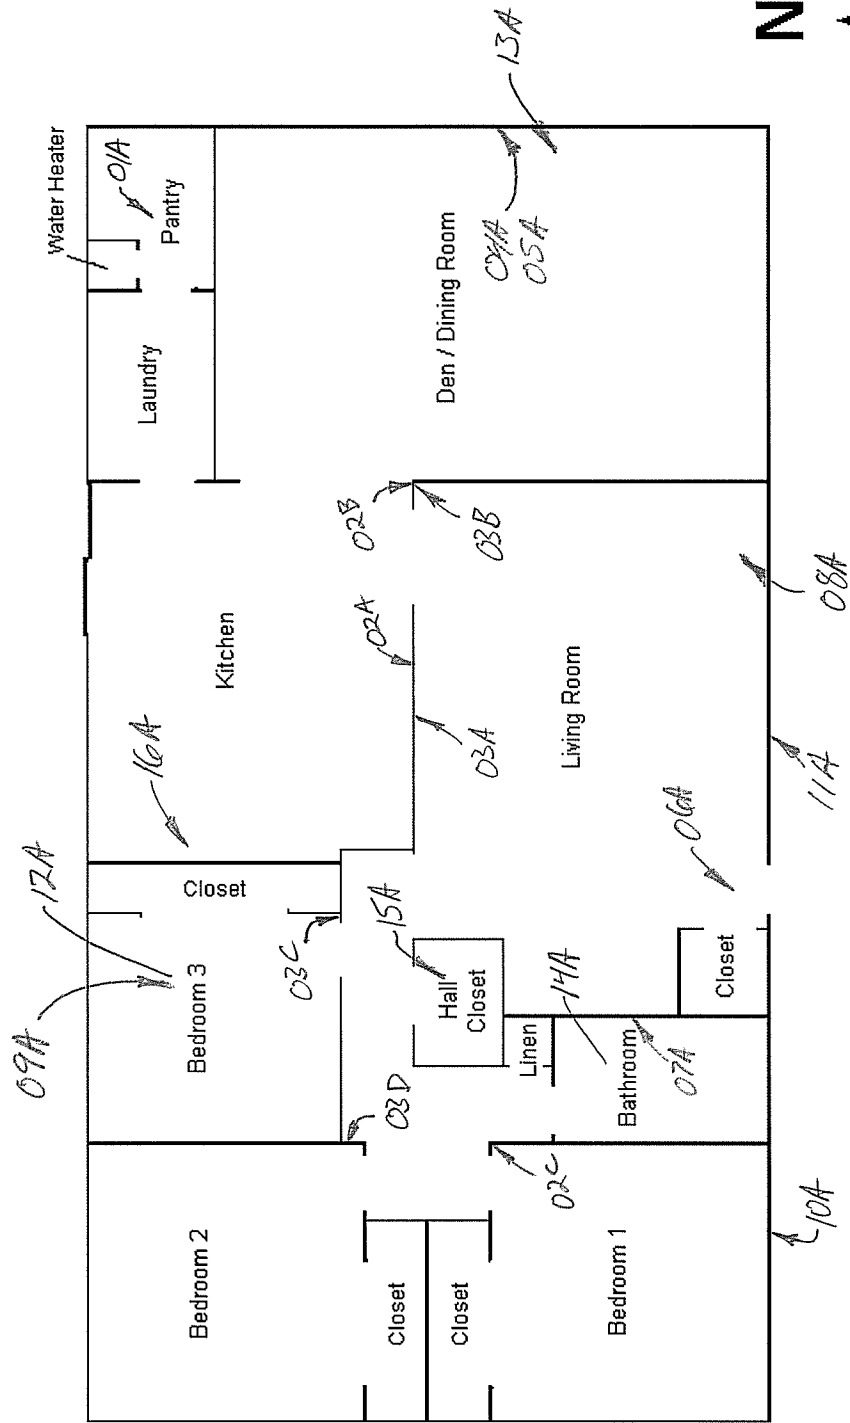
Fresno County 4402 South Bell

F12273 September 2012

1/8" = 1'

Drawing not to exact scale.

Representative bulk samples of each suspect material were collected using a scraper, chisel, or power drill. Sample locations are indicated on the bulk sample chain of custody form included with this report. The samples were analyzed using polarized light microscopy with dispersion staining (PLM) by Forensic Analytical in Hayward, CA, a NVLAP accredited laboratory.

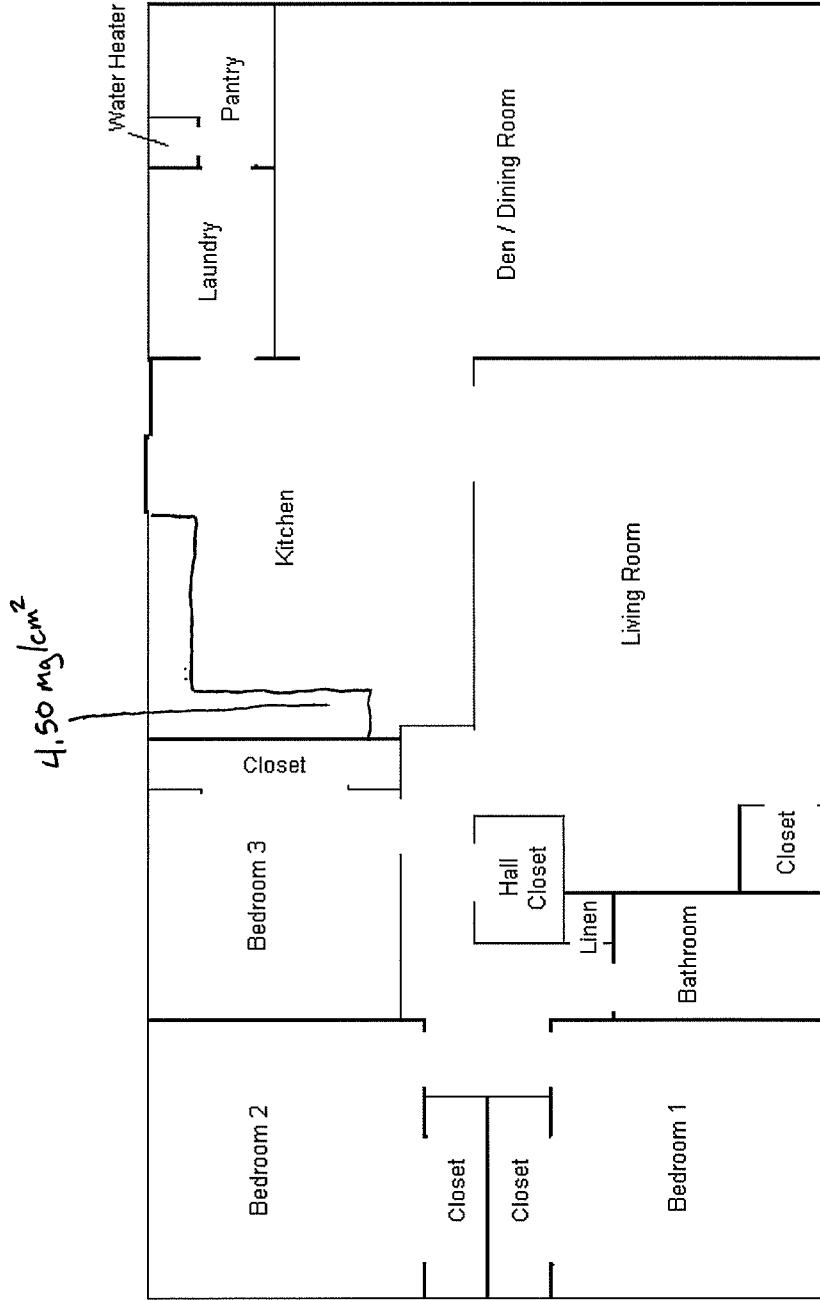
**Fresno County
4402 South Bell.**

F12273 September 2012

1/8" = 1'

Drawing not to exact scale.
